Boating Safety Circular 79

THERE ARE NO "MAINTENANCE-FREE" METALLIC FUEL TANKS

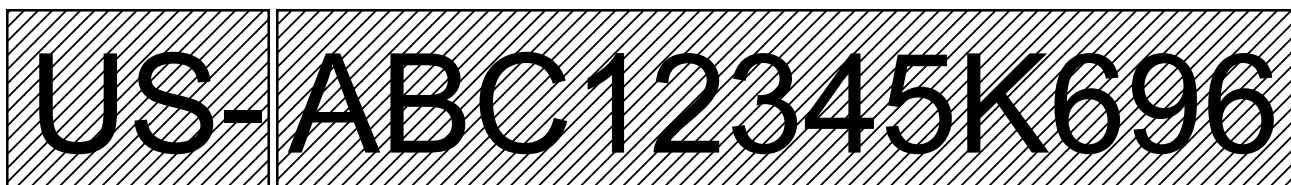
2. Surround the country code and hyphen to the left of the existing HIN format with a border or display the country code and hyphen on a separate label.

US-ABC12345K696

According to 181.27 of Title 33, Code of Federal Regulations, "If additional information is displayed on the boat within two inches of the hull identification number, that information must be separated from the

hull identification number by means of borders or must be on a separate label so that it will not be interpreted as part of the hull identification number.
