Boating Safety Circular 86

BOATING AND CARBON MONOXIDE POISONING A DANGEROUS COMBINATION

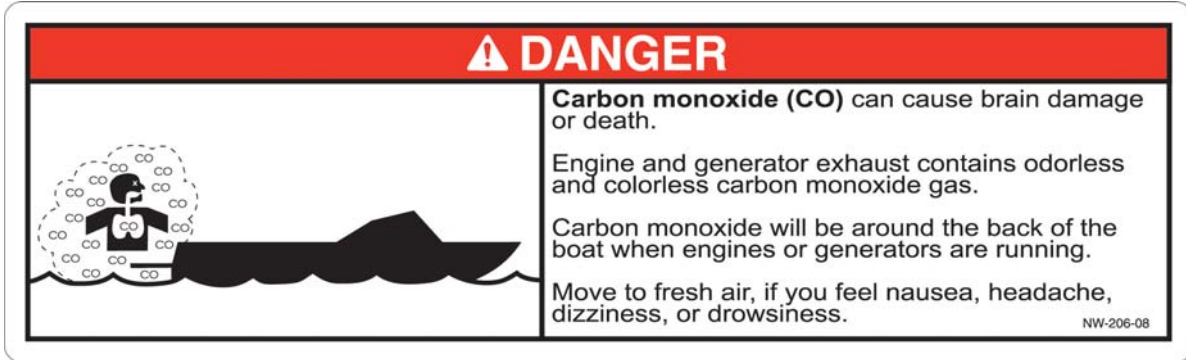
(NW 206-08) This label is required on all boats sold in the State of California in accordance with AB2222.

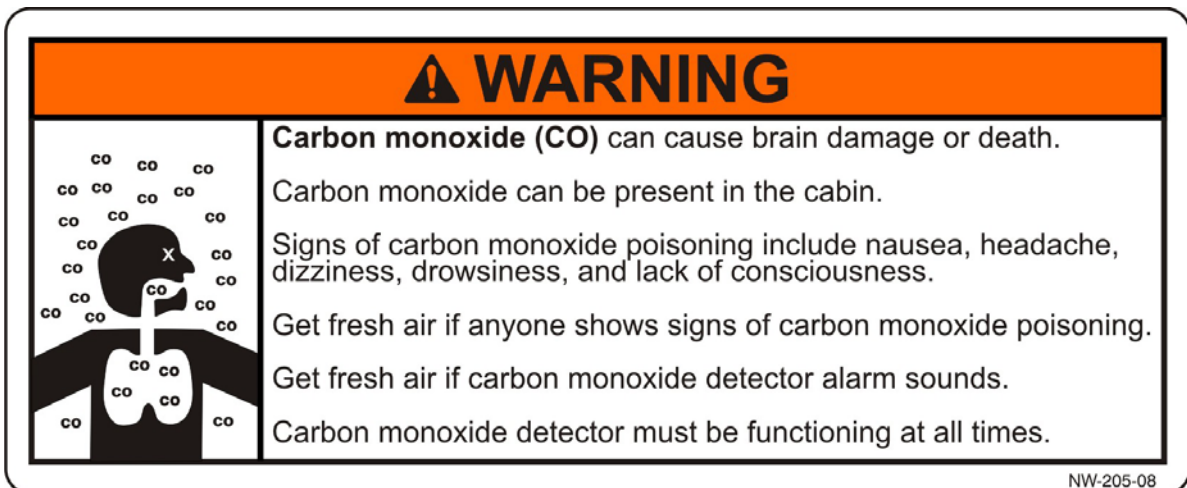
CO CABIN LABEL

(NW 205-08)

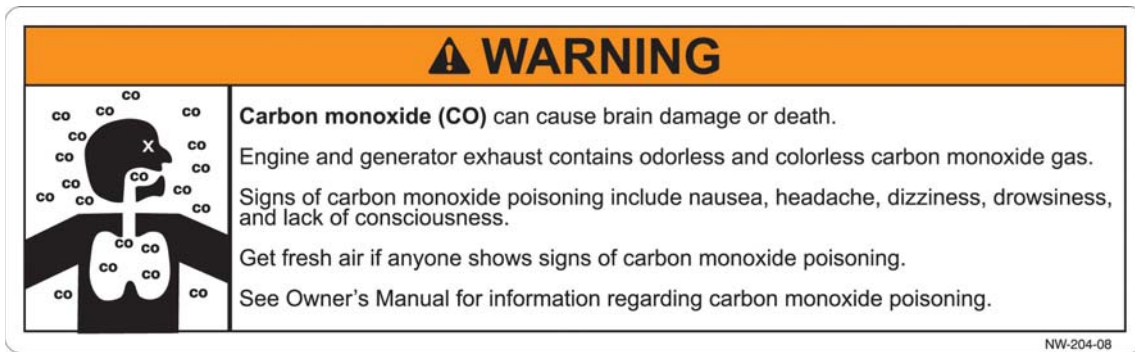
CO HELM LABEL

(NW 204-08) This label is required on all boats sold in the State of California in accordance with AB2222. [Order from NMMA \$75.00/250 plus S&H]
